**GEOMETRIC INTEGRITY ASSESSMENT
OF PETROLEUM STORAGE TANK
USING TOTAL STATION TECHNOLOGY
IN COMPLIANCE WITH API 653
STANDARDS**

This study presents a comprehensive inspection report on a storage tank (B1) at the CNR base in Abidjan, Ivory Coast. Utilizing Total Station surveying techniques with a Kolida reflectorless total station. The investigation focused on key parameters such as base settlement, roundness (ovality), verticality, and base level assessments in compliance with API 653 standards. This study focuses on the geometric integrity assessment of petroleum storage tanks using Kolida KTS 442 reflectorless total station technology, with the objectives of: Present a comprehensive measurement workflow aligned with API 653, demonstrate how total station-derived data supports detection of deformation parameters—such as settlement, out-of-roundness, and verticality deviations and evaluate compliance with API 653 tolerance limits. The inspection methodology involved the use of a total station instrument and its accessories. Temporary control points were established within the tank premises on which Total station was set up. The circumferential level of the tank base was determin

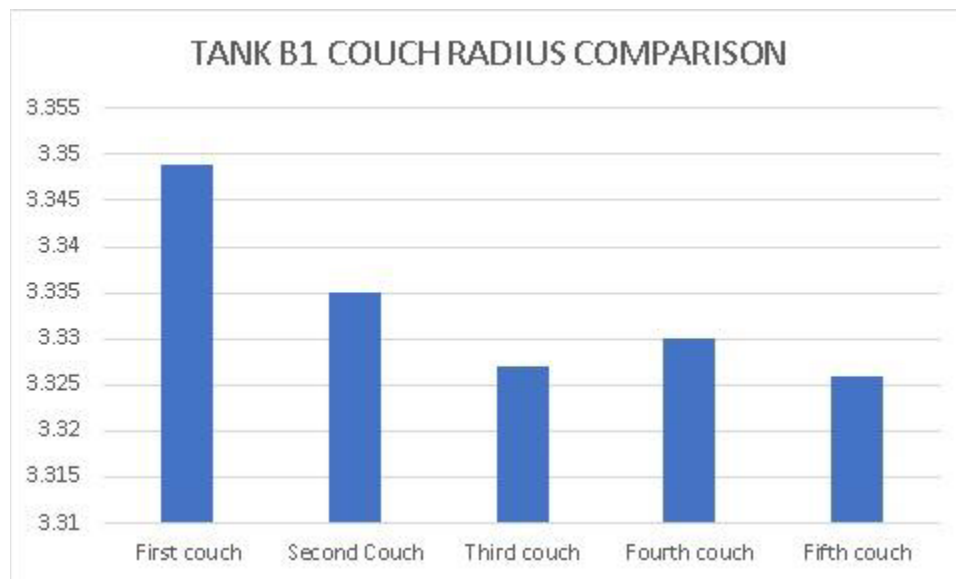
Figure 2.3 Tank B1 Radial comparison

- iii. **Ovality deviation:** We carried out ovality inspection on the five couches of tank B1 except for the where there was cluster of tanks so the total station was set up in a position very close to tank B1 whereby only the first couch could be sighted. Ovality measures the deviation of the tank's circumference from a perfect circle. There was no previous inspection report to determine the ovality of B1 as at the time of installation hence no basis for comparison but when we plotted the circumferential points, we can say the ovality is permissible.

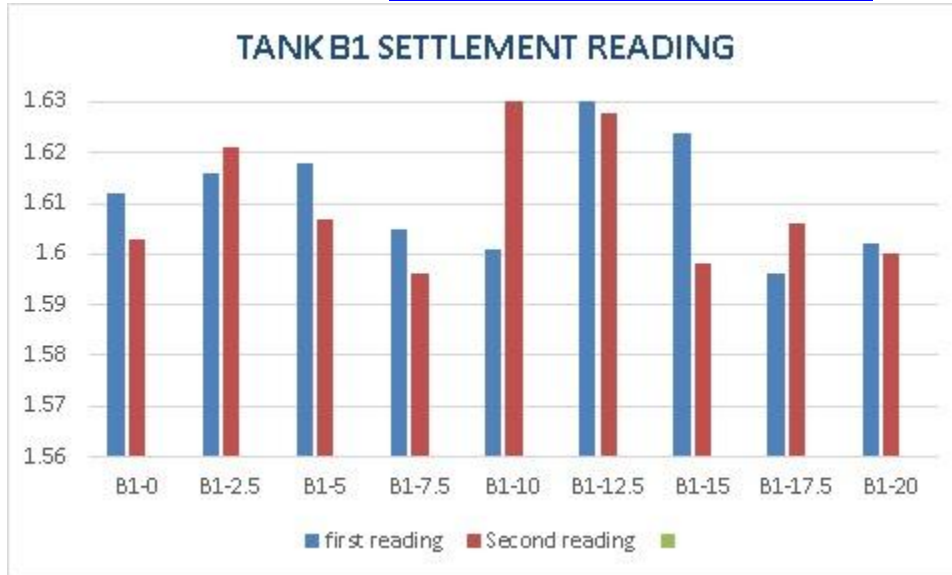
Figure 2.4. B1 base level inspection

- ii. **Base level deviation:** The base level of eight points was taken round the tank B1 circumference. Base level refers to the horizontal plane of the tank's foundation. The difference between the highest and lowest base level reading for tank B1 was 3cm. This deviation was supposed to be compared with the base level data as at the time of installation or any previous inspection. Since there is no previous base level data, we cannot ascertain the original base level of the tank.
