# APPLICATION OF ELECTRICAL METHOD FOR GEOPHYSICAL ASSESSMENT OF SUBSURFACE STRUCTURES CONTRIBUTING TO ROAD FAILURES IN SHAO-MALETE ROAD, KWARA STATE.

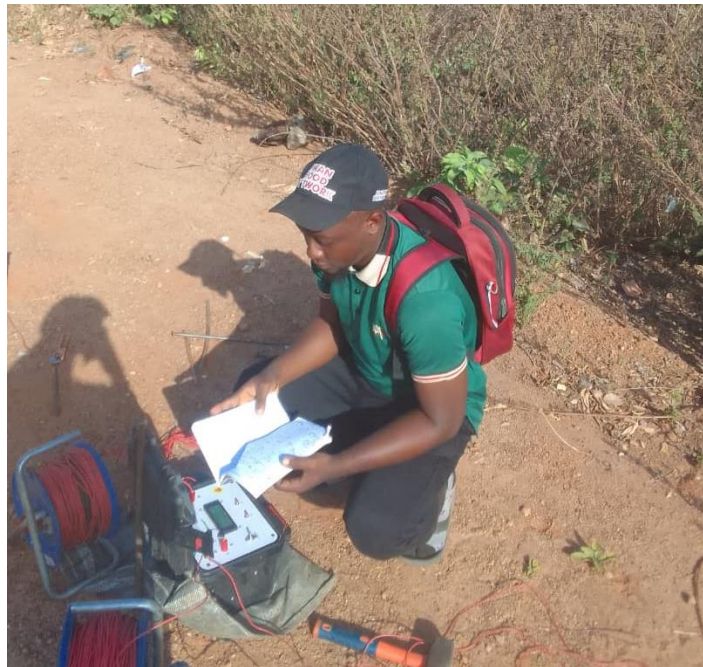
Fig. 3 Researcher and field instruments during VES survey for road failure investigation within the study area.

This study employed the Electrical Resistivity Method using the Schlumberger configuration of the Vertical Electrical Sounding (VES) technique to investigate the subsurface conditions along Shao-Malete Road that may cause or contribute to road failure in the study area. The primary instrument used for VES data collection was the HEROJAT Resistivity-meter, which measured subsurface resistance, supported by materials such as electrodes, insulated cables, hammers, measuring tapes, and a GPS reader. Figure 3 shows the field instrument and material used at the field location. A total of seventy-one (71) VES stations were established at regular intervals along Shao-Malete Road, strategically located across sections spanning 16.9 kilometres, with a maximum electrode spacing (AB/2) of 100 metres. The acquired field data were processed and interpreted using software such as Microsoft Excel for data computation, organisation, and preliminary analysis, and IPI2WIN to determine layer resistivities and thicknesses.

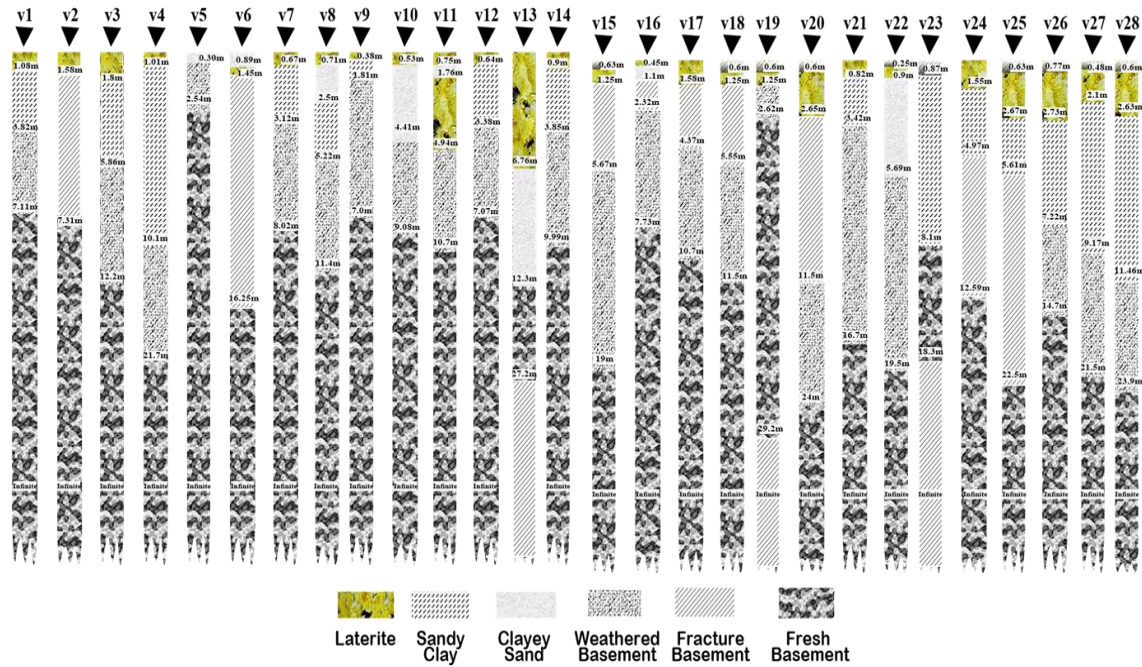
Fig. 3 Geoelectric section model for VES 1 to VES 28 along the study area

Moreover, the geoelectric section, as shown in Figures 3 to 5, derived from the VES interpretations, delineates zones of weak subgrade materials and saturated formations that correspond spatially with observed pavement failures. Areas exhibiting thin lateritic cover and thick clayey or sandy-clay sublayers show poor bearing capacity, particularly in sections where

drainage is inadequate. Also, sections with thicker lateritic overburden and shallow, compacted bedrock display higher resistivity values and are relatively stable with minimal evidence of deformation.

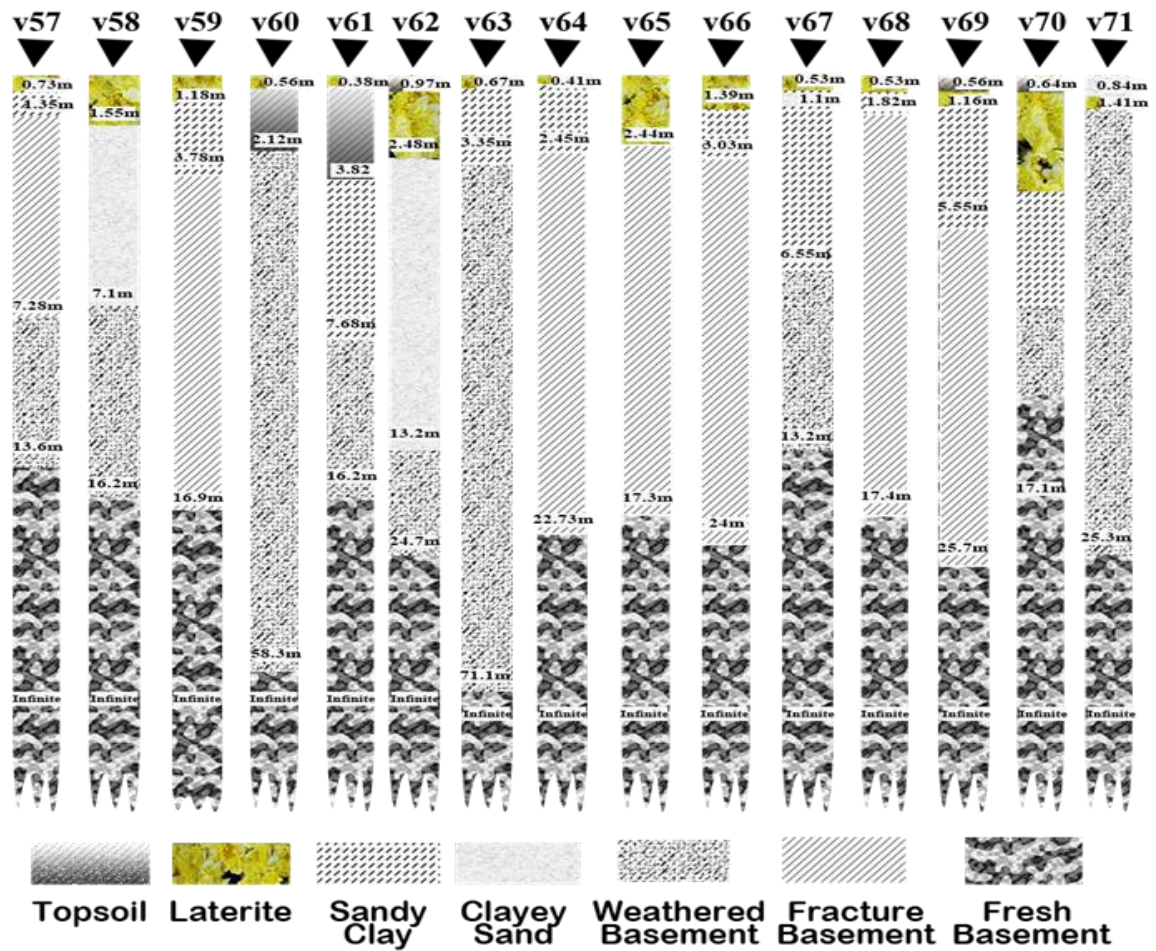
Fig. 5 Geoelectric section model for VES 57 to VES 71 along the study area

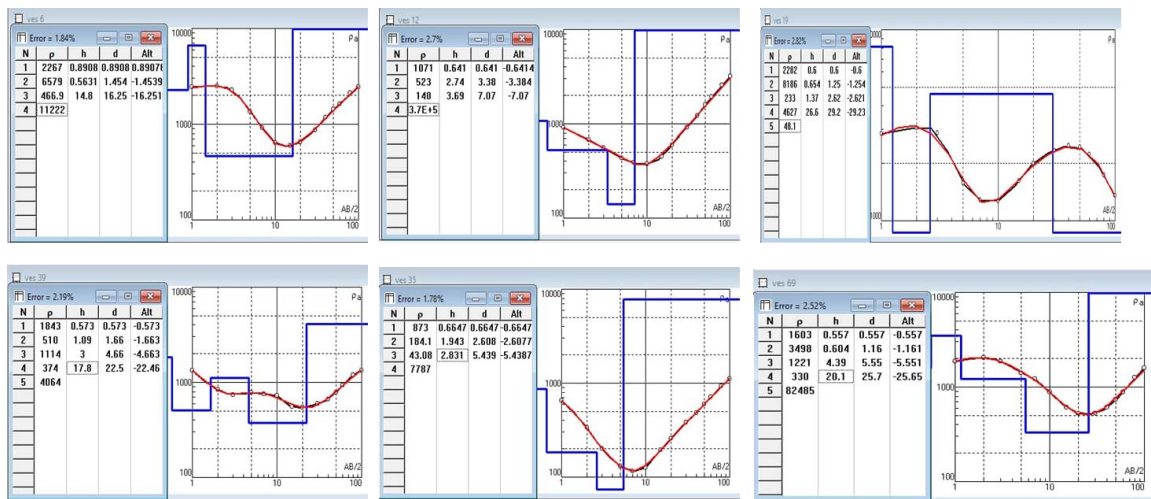
Fig. 6 Sample of IPI2WIN Resistivity-depth Plot

Figures 4, 5, and 6 show the geoelectric sections for the VES-inferred lithological units of the subsurface. Figure 6 displays examples of the IPI2WIN resistivity-depth plot images for some of the VES data results. Additionally, Table 1 presents various curve types, such as QH, H, HK, KQH, KHK, KQQ, HKH, QQH, KHH, QHH, and QHH, for all 71 VES data, with QH being the most common, as shown in the figure.
