Corrosion of Stainless Steels of Cryogenic Hydrocarbon Flare Tips (Burners) (pp. 124-136)

Abstract: Analysis of the corrosion resistance of AISI Type 304 Stainless Steel (SS) used in flare tips (burners) of natural gas (NG) extraction facilities is considered to determine the resistance of this grade of austenitic stainless steel to the aggressive corrosive actions of the environment. It was observed that the grade of SS yielded quite early to corrosion attacks which gave effects to scaling, flaking, pitting, material thinning and flare distortions in the burners contrary to expectations. This necessitated replacements with costs and thus there was need to analyse the causes and find solutions to the problem in such a way that a longer service time could be obtained with minimal shut downs. The solution was found in the grades of SS with balanced higher quantities of nickel, chromium, molybdenum and SS type with partial nitrogen substitution for nickel which helps in stabilization of the austenite structure. There was need to balance the contents of the alloying elements to ensure the desired microstructure is preserved. Further study is required in the area of “weld decay” caused

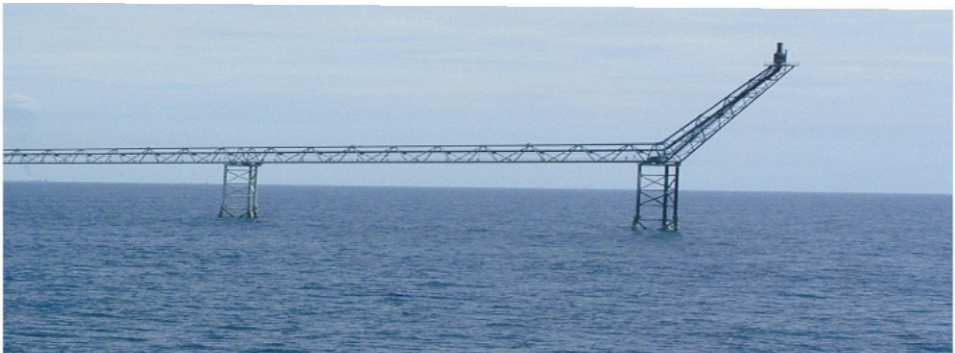
Figure 1: Cryogenic Flare Header / Burner Arrangement

The flare header is 50 cm ID x 48 m tall above mean sea level. The flare header and burner are made from 304 stainless steel. Both flare header and flare burner have normal operation conditions of 2.8-3.5 Barg at -65 °C. The flare burner is of smokeless combustion design. Any liquid reaching the tip is atomized by the sonic flow jet and burned.

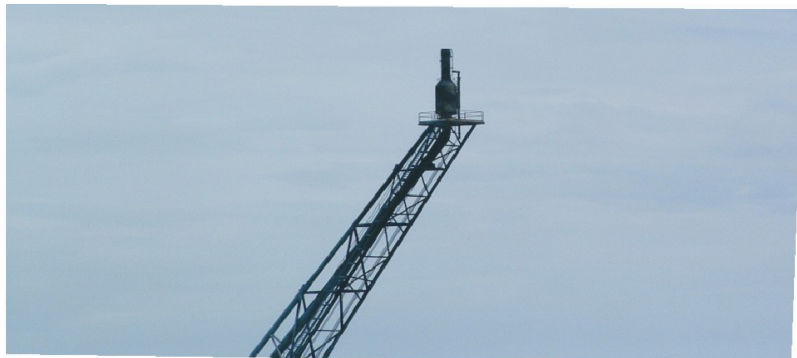
Figure 2: Expanded View of Flare Header / Burner

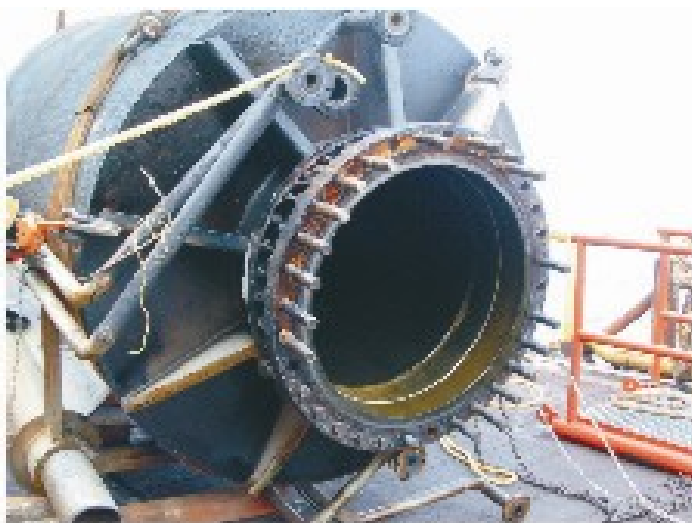
Figure 3: View showing Bottom Area of Burner

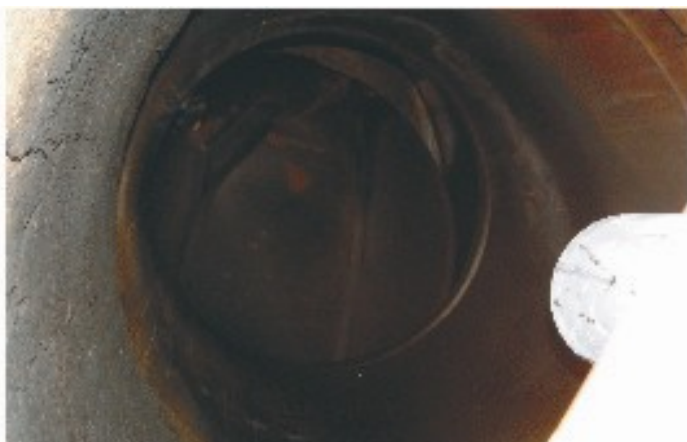
Figure 4: Corrosion Effects in Burner Internal

- Minimal signs of “sweeps” were noticed at both inlet and outlet ends of the burner suggesting erosion corrosion played insignificant role in the corrosion damage.
- Some of the vanes of the burner have broken off at their roots.
- The internals have significantly thinned out (material loss) with scales and flakes.

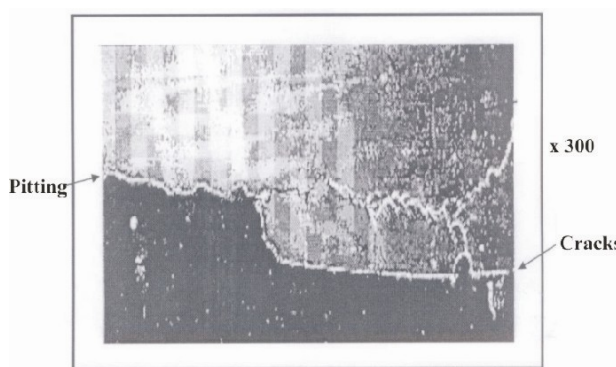
- A chemical composition analysis result of Table 3 showed that the flare burner material was the same in composition with AISI Type 304 specified.
- Metallurgical examination of pitted regions identified cracks at the weldments, an indication of negative response to stress occasioned by the flow and thermal conditions (Cragolino *etal* 2006). Figure equally suggests that the weldments may not have experienced the desirable post-weld heat treatment (Parmar, 2007).
- The crack direction was observed towards the inner portion of the metal as against running along the surface.

Figure 7: Pitting and Cracks Observed in Burner

Based on the results of the analysis, the standard recommendations of this study are found in tables 5, 6 and 7. The following materials were recommended for the flare burners: Material A: AISI Type 304N SS; Material B: AISI Type 310 SS and Material C: AISI Type 314 SS. The recommendations were implemented. Replacement flare burners were produced with the recommended materials and were installed and put to use. The actual elemental compositions of these grades of steels used for the production of the new replacement burners are listed in Table 5 below alongside their AISI standards. Table 7 lists the new burners service data after installation and use.

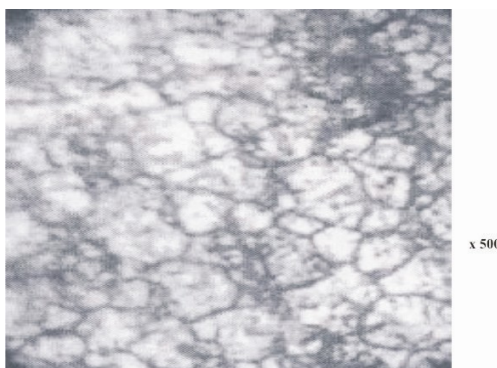
Figure 8: Microstructure of the Weldment

Flare Burners: Units 1, 2 and 3.	The crack direction was observed towards the inner portion of the metal as against running along the surface.	Intergranular attack.
