UNMANNED AERIAL VEHICLE (UAV)-BASED PRECISION AS-BUILT SURVEYING FOR INSTITUTIONAL BUILDINGS

This study utilizes UAV-based photogrammetry to perform a high-precision 3D as-built survey of newly constructed laboratory buildings at Bells University of Technology. The approach integrates GPS-enabled UAV data acquisition with advanced photogrammetric processing using Agisoft Metashape Professional, AutoCAD Carlson 2021, and Agisoft Viewer to produce high-resolution orthophotos and accurate 3D spatial models. Comparative analysis between orthophoto-derived measurements and architectural design specifications indicates dimensional deviations predominantly within ± 5 mm across most building elements, confirming construction accuracy. However, the roofing components exhibit deviations of 90 mm in length and 100 mm in width, exceeding international tolerance thresholds, thereby indicating non-conformance that may impact structural performance and envelope integrity. Positional accuracy was further validated through geospatial overlay on Google Earth. The findings demonstrate the technical reliability of UAV-based as-built surveys for construction validation, offering a robust tool for qual

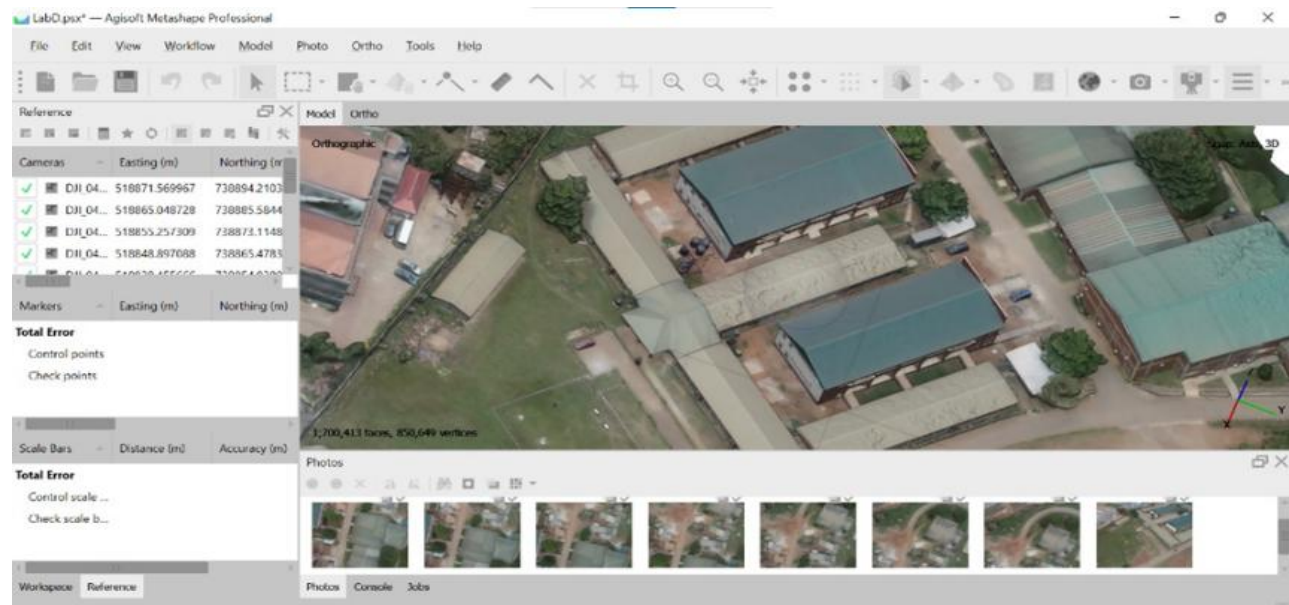
Image processing was performed with **Agisoft Metashape Professional** (Agisoft LLC) to generate a high-resolution orthophoto of the project area. The orthophoto was further visualized and

Figure 2: Agisoft Metashape Professional Software Environment

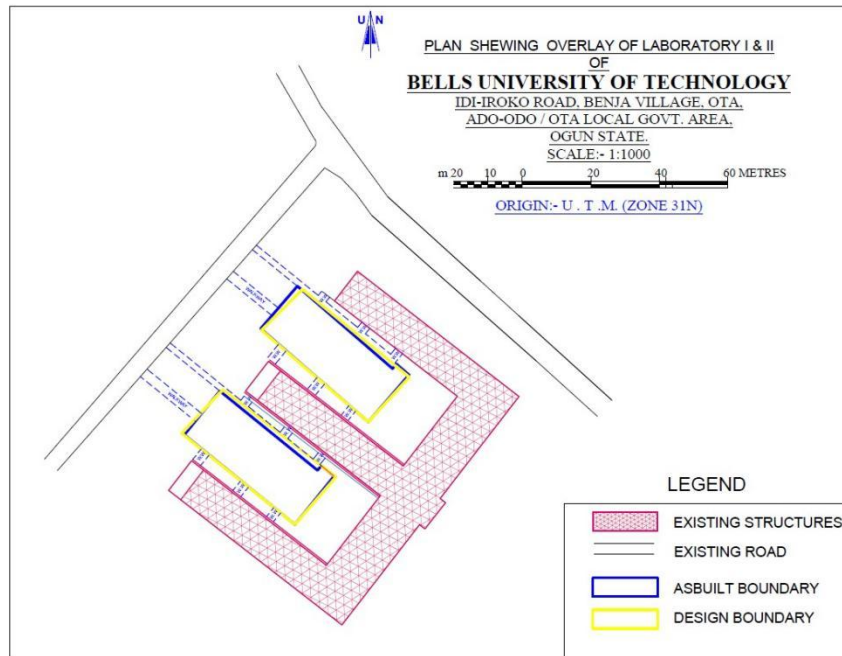
Figure 3: Plan Showing Overlay of the Laboratory I & II on the School Base map

In the course of the research, four buildings were surveyed; however, this paper focuses on two laboratory buildings, as the results across all structures demonstrated a consistent pattern. The as-built site plans of the selected buildings were overlaid onto the existing campus base map. With the exception of the roofing components, all recorded dimensions showed strong alignment with the original architectural design specifications. as shown in Figure 3.

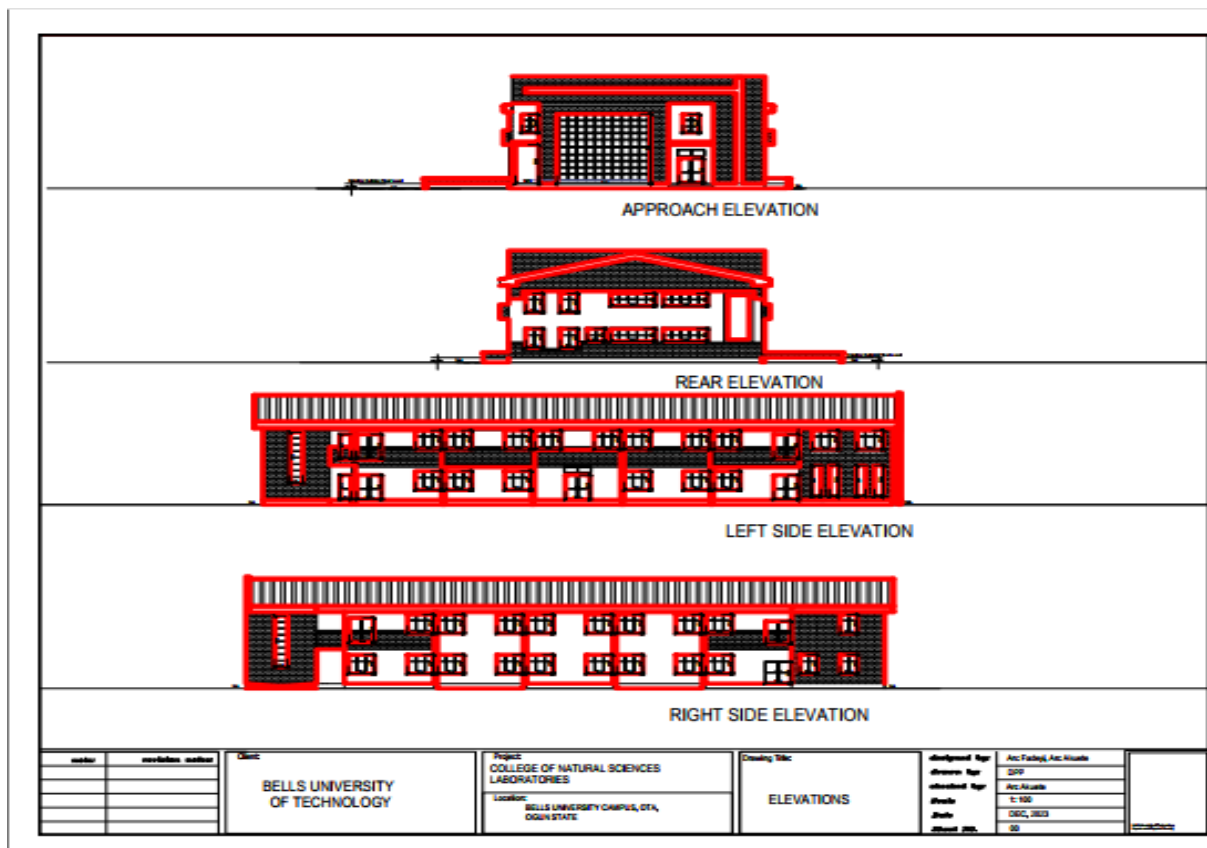
Figure 4: Architectural Design for Laboratory I & II

Some major components like doors, windows, roof dimensions of the different sides or view of the architectural design and as-built survey plans were compared to assess conformity or disparities. Findings were subject to Industrial/International tolerance standard to determine level of tolerance/accuracy (acceptable or not acceptable). Table 1 and 2 respectively show the general and concrete Tolerance standards for Building construction while Figure 4 shows the different views of the Architectural Design for Laboratory I & II.

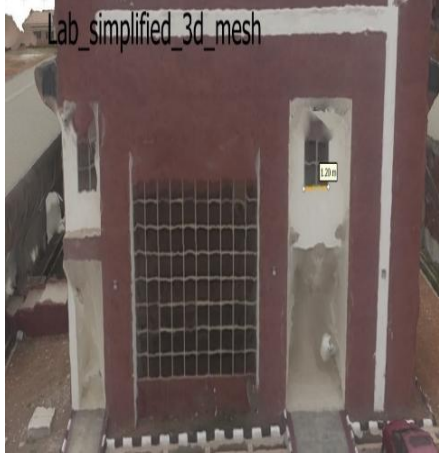
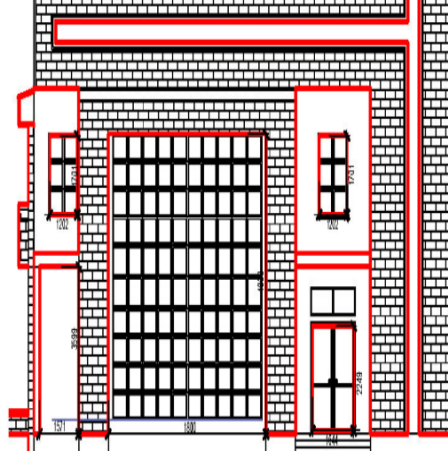
<p>Window (1) analysis of the Laboratory Front View</p>

<p>The measured length of the highlighted window side is 1.202 m in the architectural drawing and 1.20 m in the orthophoto, resulting in a 2 mm difference. This discrepancy is within acceptable tolerance limits, indicating that the window dimensions on the ground conform to the intended design specifications.</p>
2	<p>Window (2) length analysis of the Laboratory (Rear View)</p>

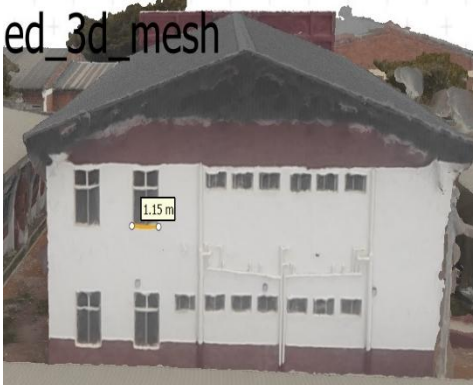
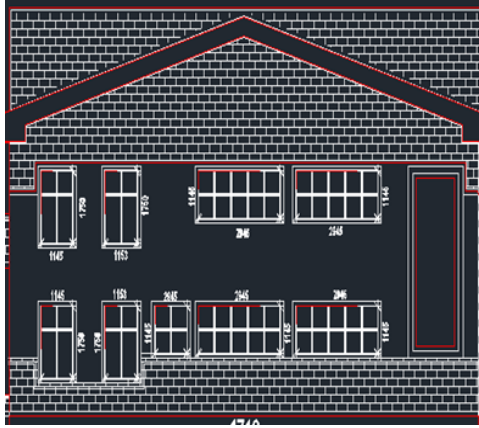
<p>Window (2) length analysis of the Laboratory (Rear View)</p>

<p>The measured length of the window side in the architectural drawing is 1.145 m, while the corresponding measurement from the orthophoto is 1.15 m. The 5 mm difference between the two is within acceptable tolerance limits, indicating that the on-site measurement complies with the architectural specification.</p>

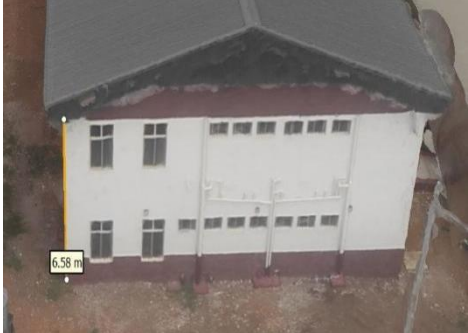
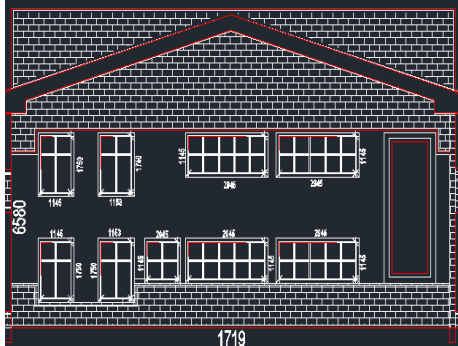
<p>Height analysis of the building/ Laboratory (Rear view)</p>

<p>The building height measured in the architectural drawing is 6.58 m, which matches the measurement obtained from the orthophoto. As there is no discrepancy between the two, it can be concluded that the on-site building height aligns precisely with the architectural specification.</p>

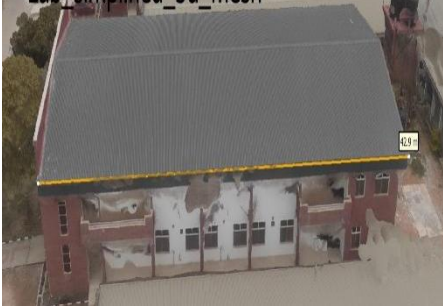
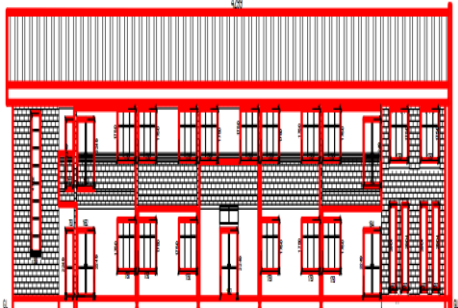
<p>Roof length analysis of Laboratory the (Rear view)</p>

<p>The building roof length is specified as 42.99 m in the architectural drawing, while the orthophoto measurement indicates 42.90 m, resulting in a 0.09m deviation. This discrepancy exceeds acceptable tolerance limits, confirming non-compliance with the intended design specifications.</p>
<p>5</p>	<p>Door width of Lab</p>

The table (Table 4) and chart analysis (Figure 5) describe the comparative analysis between orthophoto-derived measurements and architectural designs revealed minimal deviations of 0 to 5 mm across most building components, demonstrating a high level of construction accuracy. However, the roofing wings exhibited deviations of 90 mm and 100 mm, surpassing the international tolerance limits of ± 5 to ± 10 mm for length and ± 5 mm for width, respectively. These significant discrepancies suggest potential non-compliance that may compromise the structural integrity and weatherproofing of the roofing system. This study underscores the effectiveness of UAV-based as-built surveys in early detection of critical deviations, thereby enhancing quality

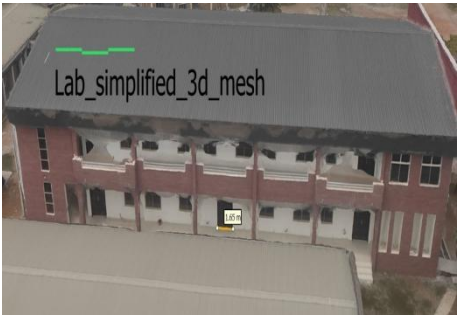
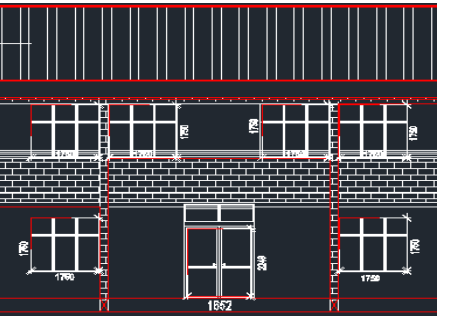
<p>Door width of Lab</p>

<p>The door width measurement of a major entrance for architectural design is 1.652m while the orthophoto is 1.650m. this falls within acceptable tolerance.</p>
<p>6</p>	<p>Roof (2) width of Lab (side view)</p>

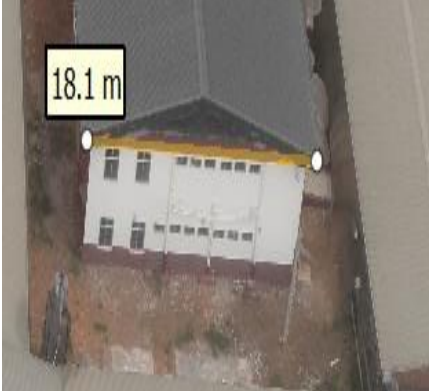
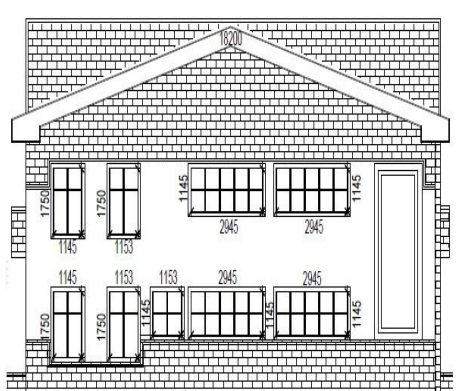
<p>Roof width of Lab (side view)</p>

<p>The measured roof width from the architectural drawing is 18.20m, whereas the orthophoto measurement is 18.10m, indicating a deviation beyond acceptable tolerance limits. This discrepancy clearly demonstrates that the constructed roof does not conform to the intended design specifications.</p>

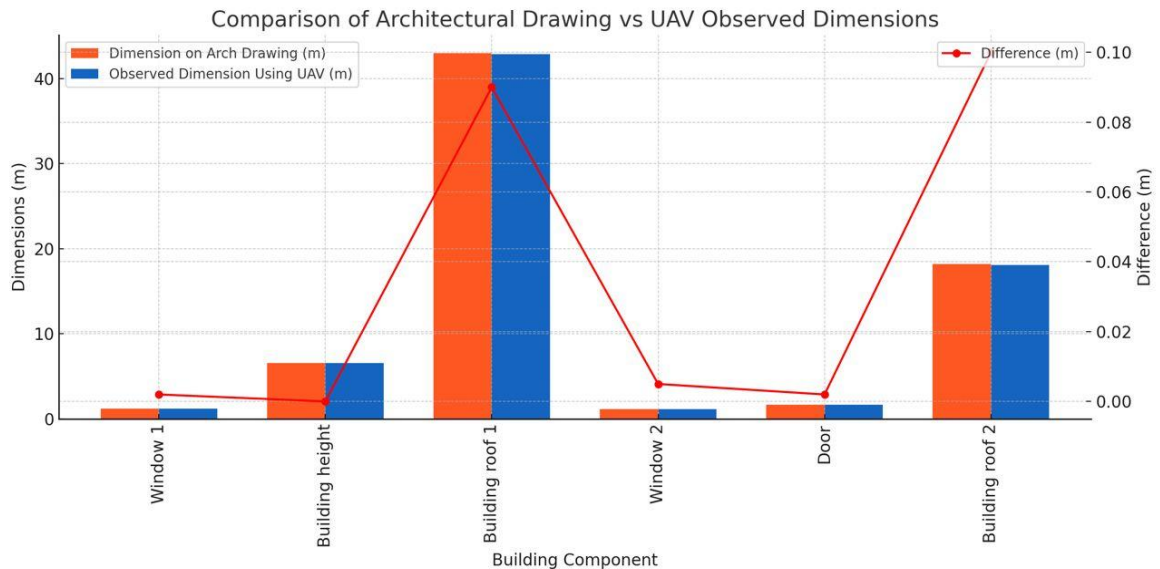
Figure 5: Chart Showing Comparison of Architectural Drawing Dimensions and Observed Field Measurements using UAV
