Journal of  
Spatial  
Information  
Sciences

## **TERRAIN ANALYSIS ALONG MAJOR ROADS IN UNIVERSITY OF LAGOS CAMPUS**

### Abstract

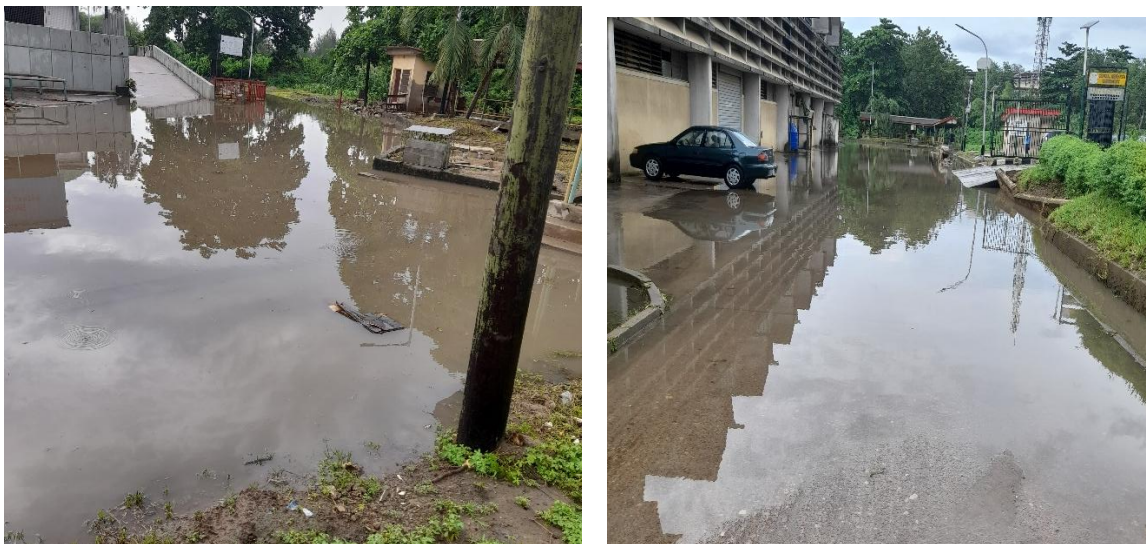
Figure 1: Typical flood along Oduduwa road by Faculty of Engineering workshop after rainfall.

Terrain analysis of the major roads in the University's main campus is important for many reasons. The University of Lagos Akoka (main) campus is situated close to the Lagos lagoon. This has resulted in occasional flooding on the campus after any slight rainfall. While most of these roads were designed as part of the master plan of the University, there have been tremendous changes in the landscape of the University between the inceptions of the University till date. Flooding has therefore increased in recent times with many parts of the major roads flooded after every rainfall both on campus and in Lagos generally (Ndimele et al., 2024). An example of flooding along the road in University of Lagos is a flooded portion of Oduduwa drive, leading from Faculty of Engineering through the Lagoon front to the Vice-Chancellor's lodge as shown in Figure 1. It could be observed that water has taken over this portion of the road and some parts of Faculty of Engineering workshop.
