# Corrosion of surface facilities of an industrial concern in the niger delta area of Nigeria splased by produced water

## C. N. Anyakwo

**Abstract**

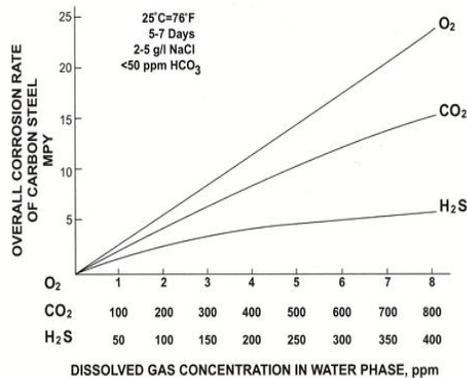
.
Fig. 2. Dissolved gas concentration in water phase, ppm.

Fig. 4. was generated for 2-5$gl^{-1}$ of NaCl at 25$^o$C. The NaCl content of the produced water (table 1) is close to that of Fig. 2. The splashing action however, lingered for many more days and the ambient temperature was well above 32 $^o$C and the concentration of the bicarbonate anion, $HCO_3^-$ of 1976.40 $gl^{-1}$ is well above the maximum limit shown in Fig. 4. The combination of these three factors should cause the bicarbonate ion to accelerate the corrosion of the carbon steel facilities. Furthermore the relatively high $HCO_3^-$ concentration attests to the preponderance of $CO_2$ corrosion mechanism. The high $Cl^-$ anion concentration is indicative of high chloride content that is balanced by the relatively high $Na^+$ cation concentration. The preferential close
