## Effect of silane treatment on the impact strength properties of oil palm (EFB) fiber- reinforced polyester composites

### Abstract

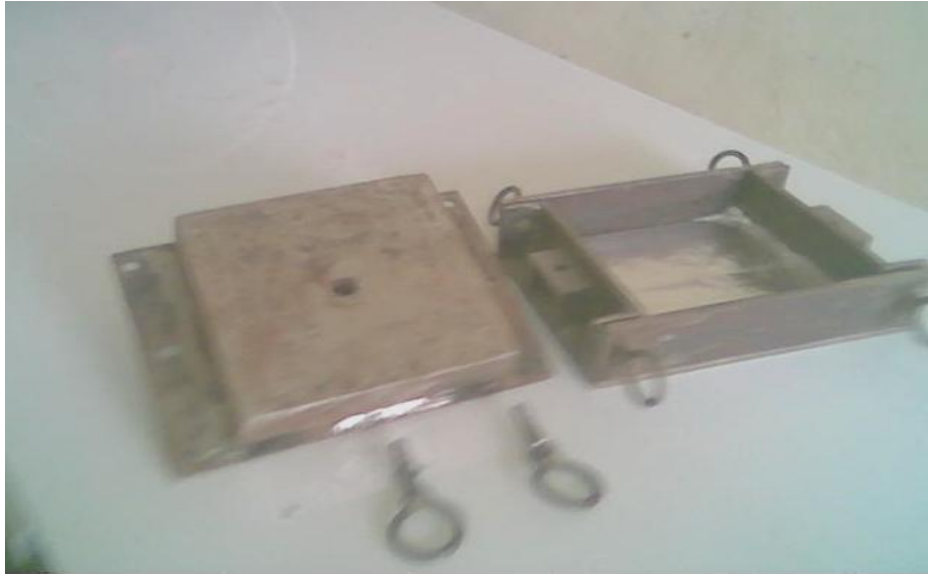
Fig. 3. A two-part mould (cope and drag).

A two-part mould facility (mild steel flat 4mm thick sheet) - of dimensions of 150mm x 150mm with active surfaces ground, pre-designed cavity of 5mm depth, with clamping bolts in place fabricated at the Dantata and Sawoe mechanical workshop, Abuja, as shown in Figs. 3 and 4, was adopted in the production of test specimen plates.

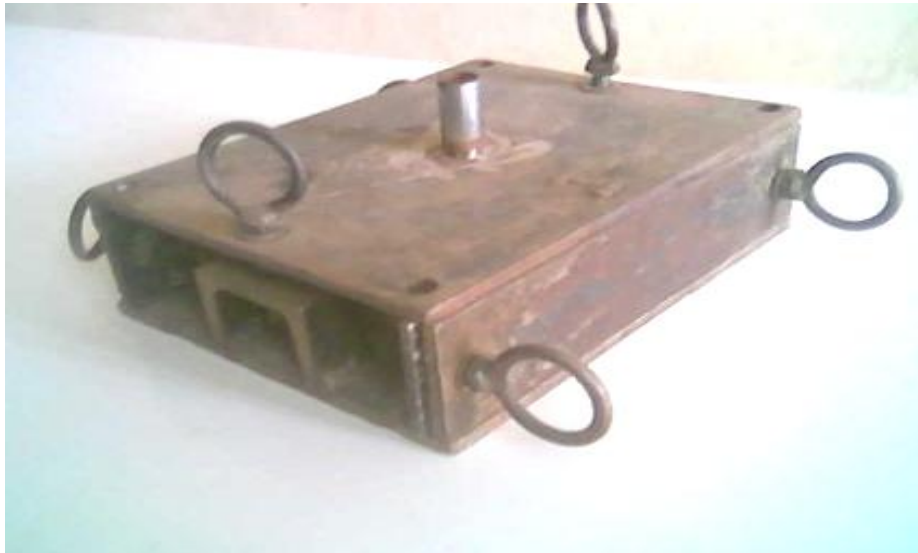
Fig. 4. A-two part mould (assembled).
